STATE HOUSE EXTERIOR AND GROUNDS RESTORATION PROJECT UPDATE - MISCELLANEOUS PHOTOS

5-02-2024

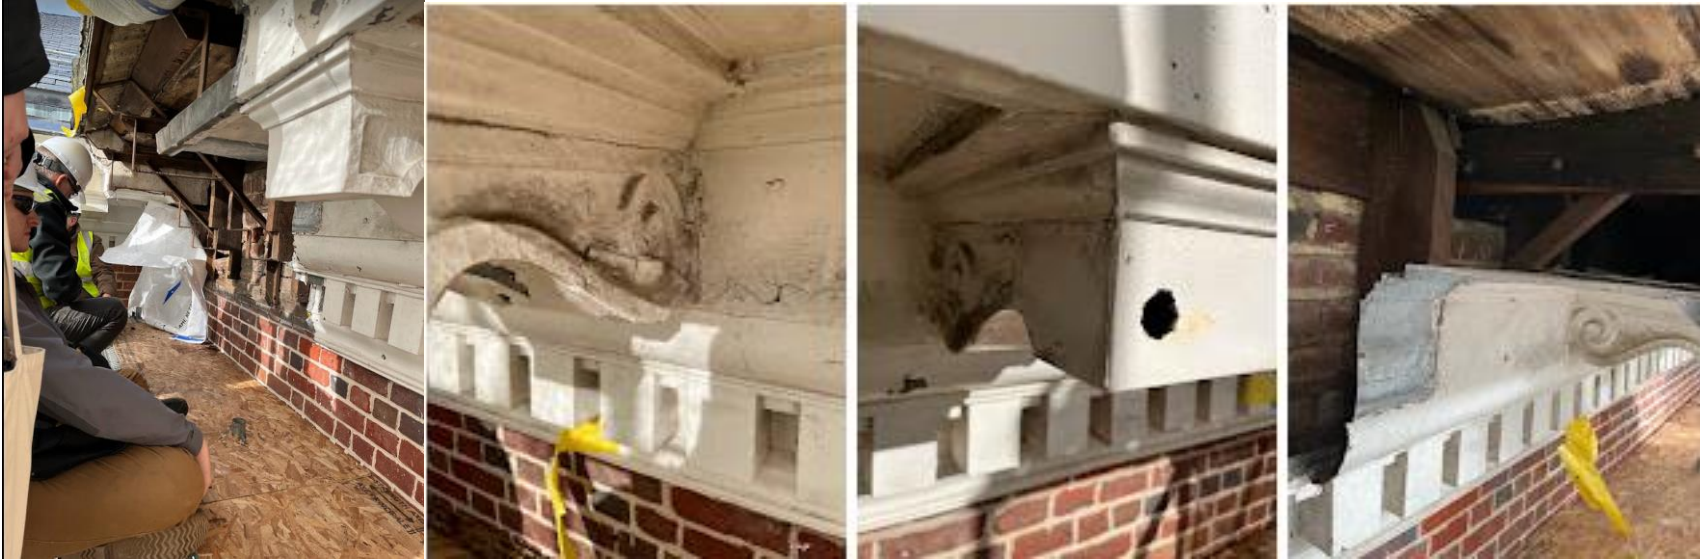
Concealed conditions exposed

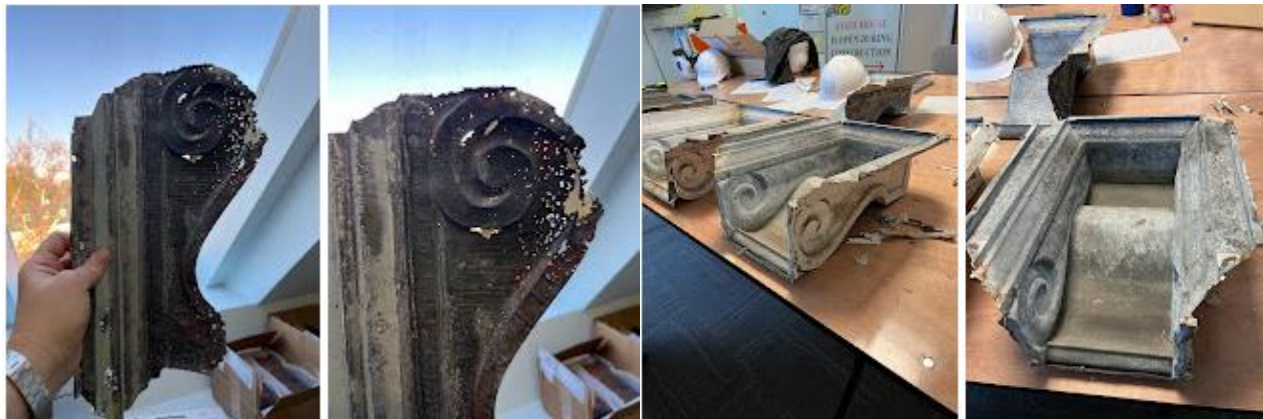
Condition of existing metal cornice in situ

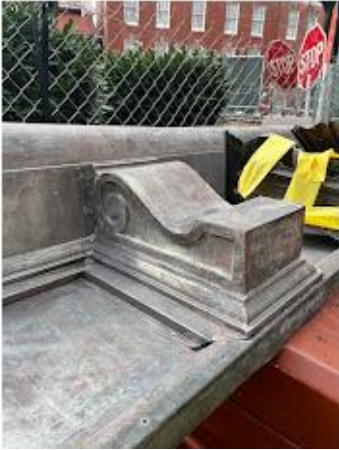
Metal cornice - condition of corbels

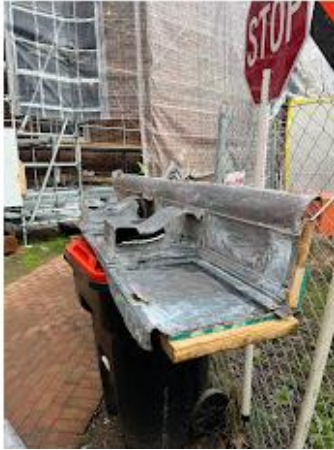
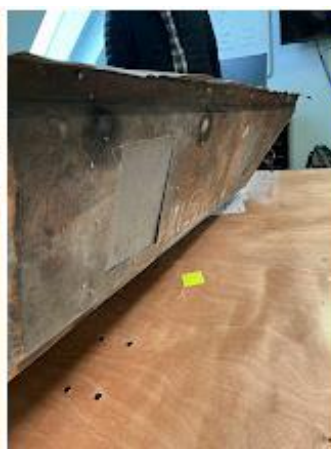
Cornice section w/ lead-based paint abated

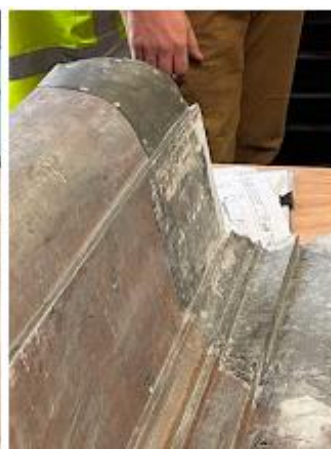
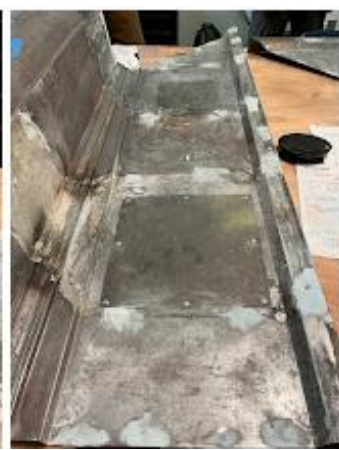
Restoration in process

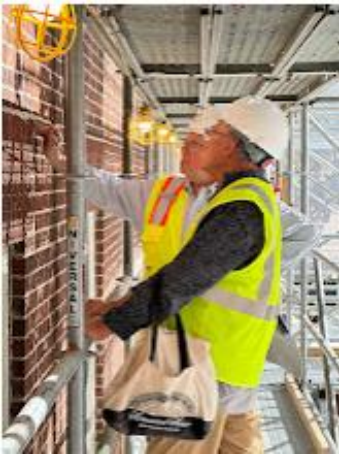
Investigation w/renowned mason, Ray Cannetti

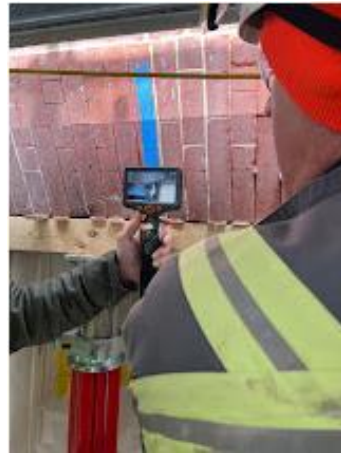
Investigation of concealed spaces using pin-hole camera

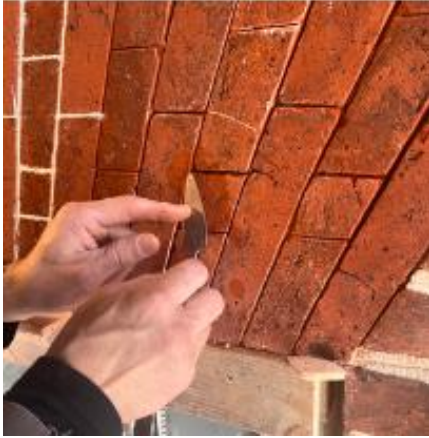
Restoration in process

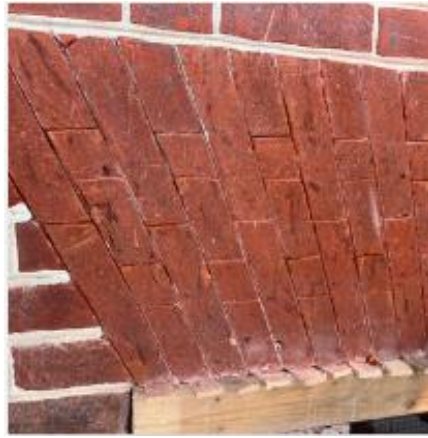
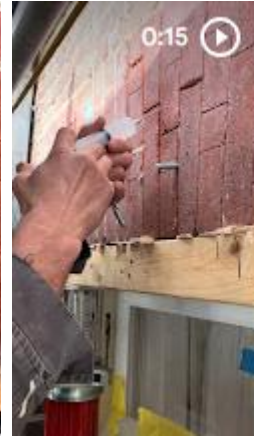
Micro-injection of lime-putty mortar using syringes

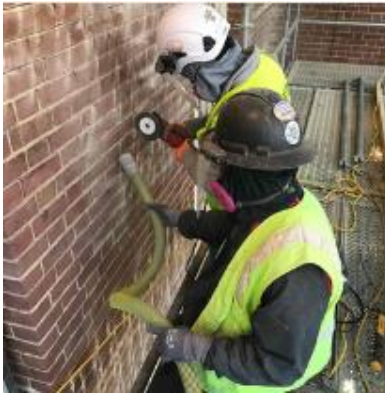
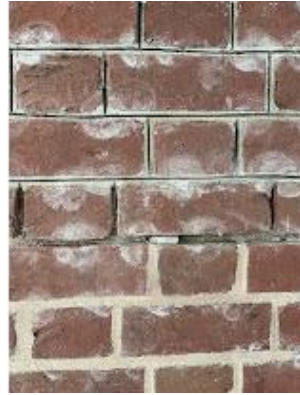
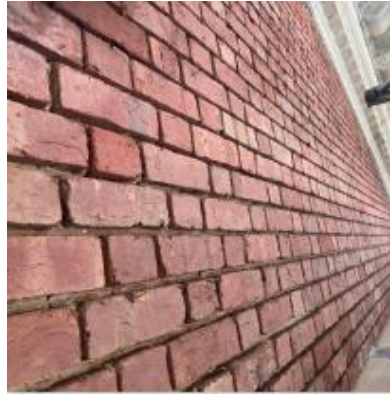
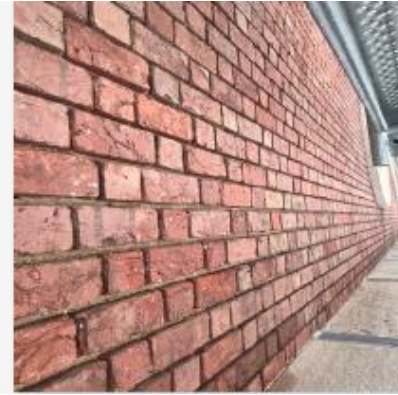
100% of Annex brick mortar joints ground & chipped out with no damage to brick

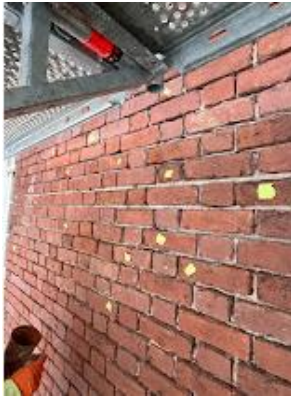
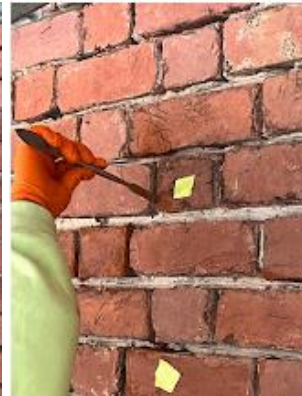
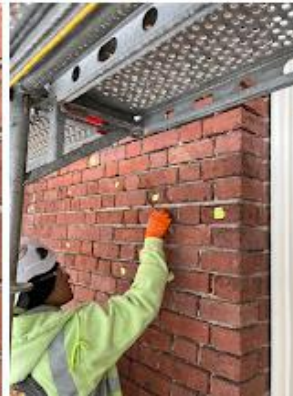
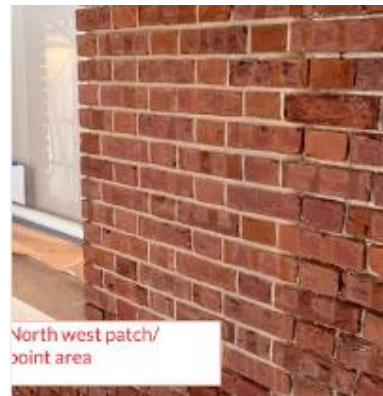
Broken or cracked brick identified and patching in process

Pointing mock-up approved

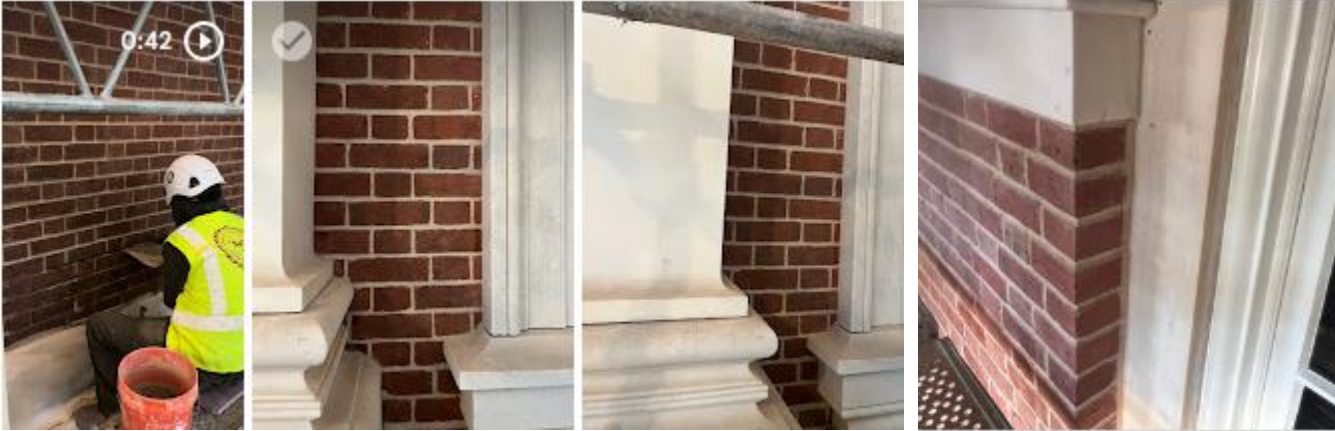
Pointing in process and restoration completed on various sections of wall

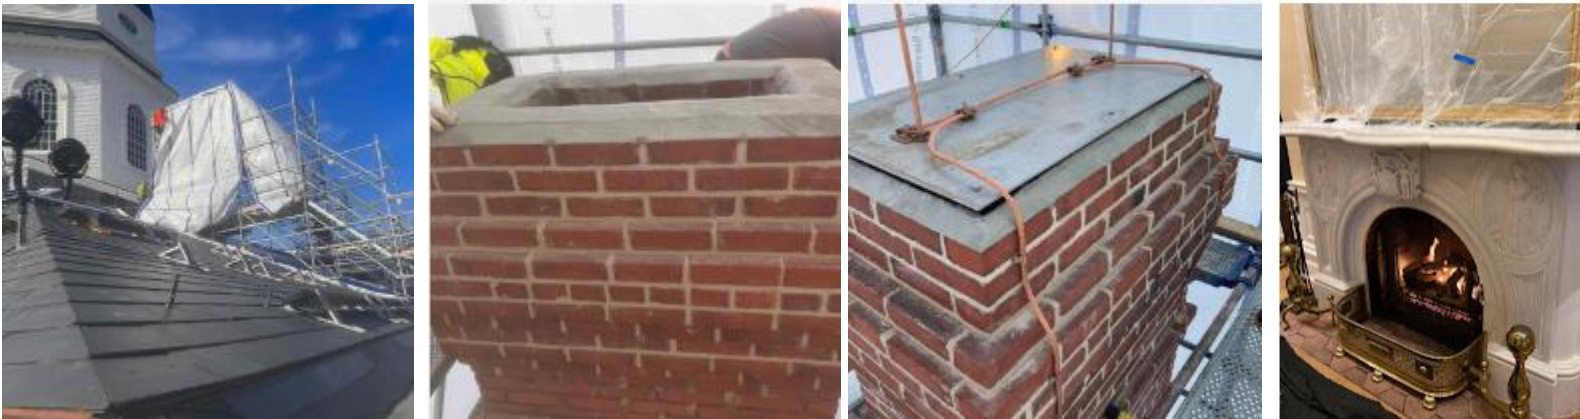
Governor's chimney under restoration

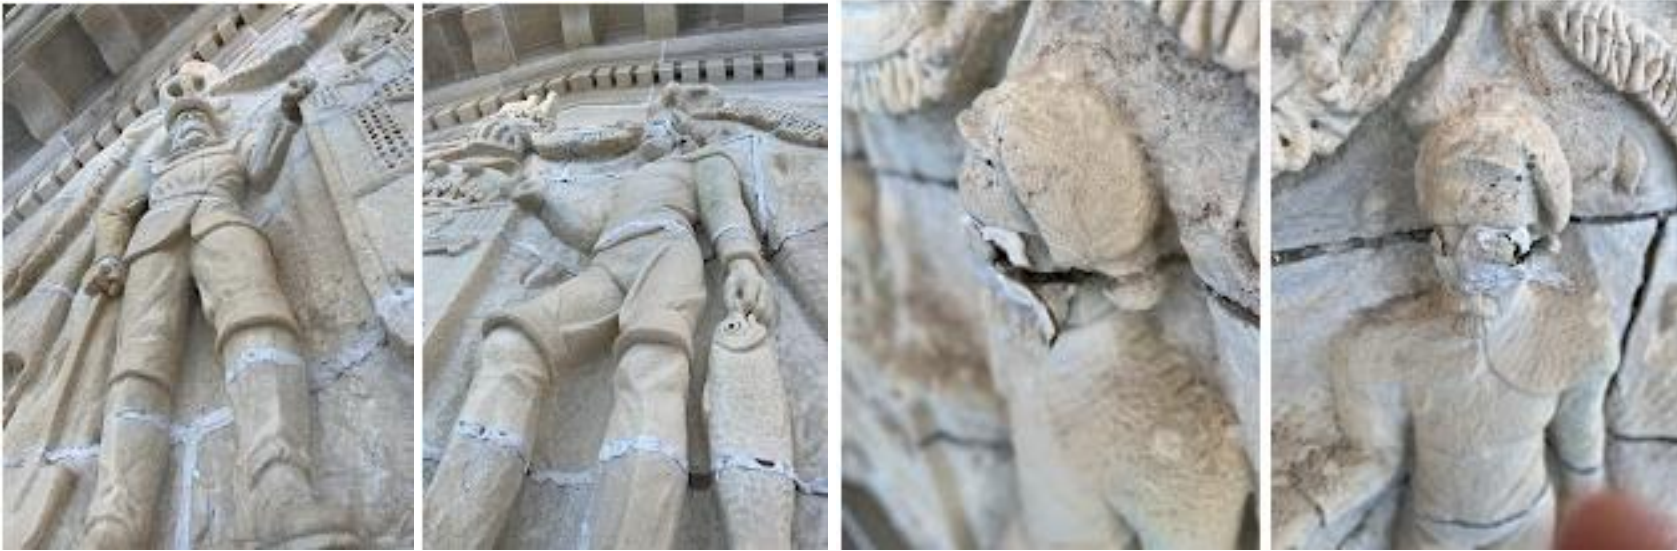
Existing condition of State Seal; deteriorated stone held together by failing (and inappropriate) caulk

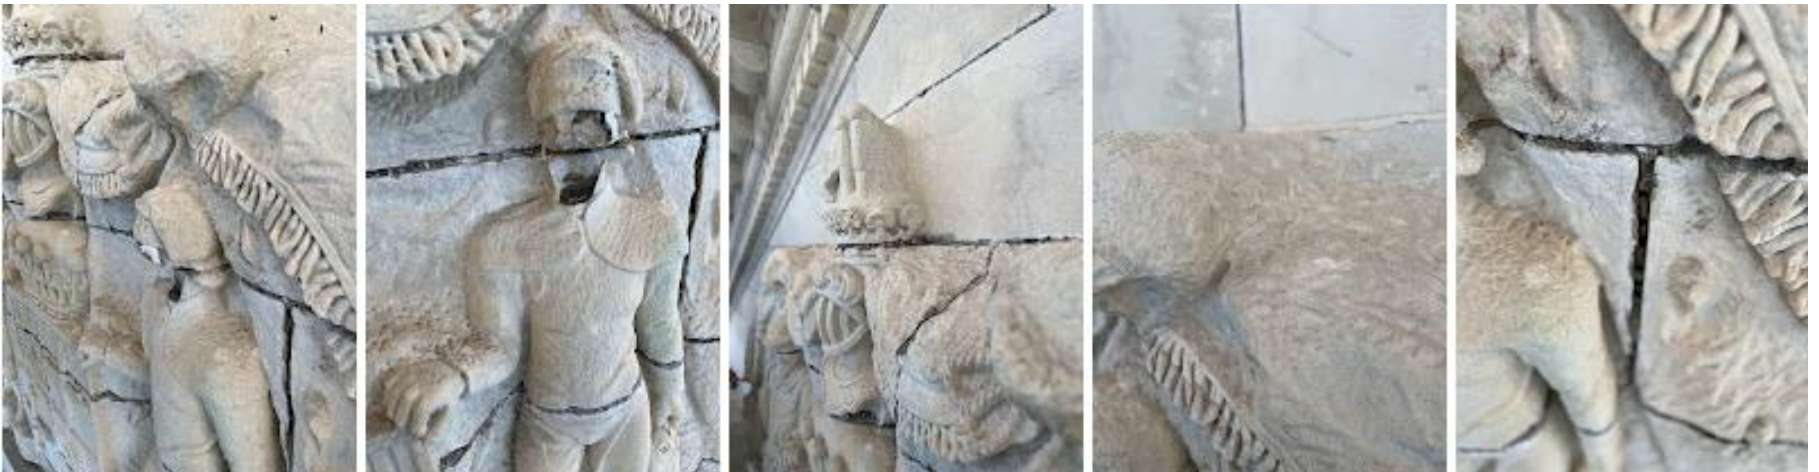
Inappropriate sealants and loose sections of stone removed; joints being prepped for removal of loose mortar

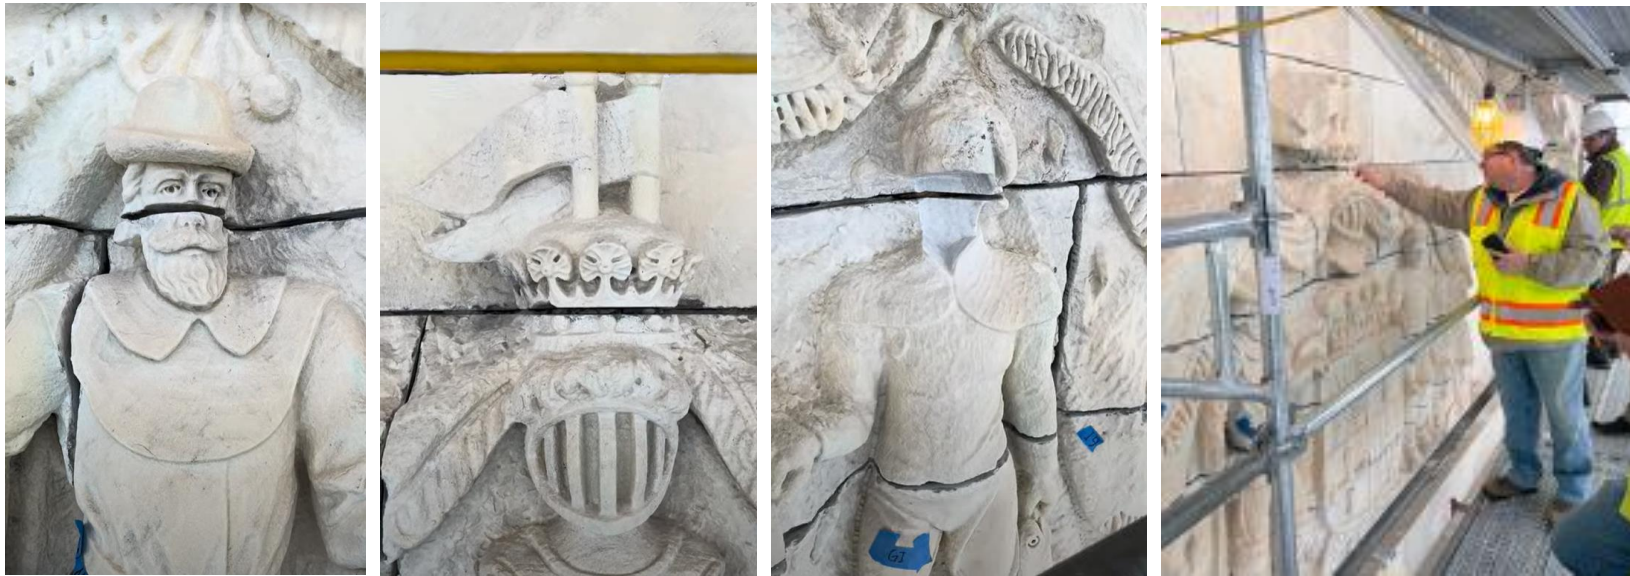
Fully prepped for restoration measures including stone dutchmen, crack grout injection, micro-pinning and pointing mortar

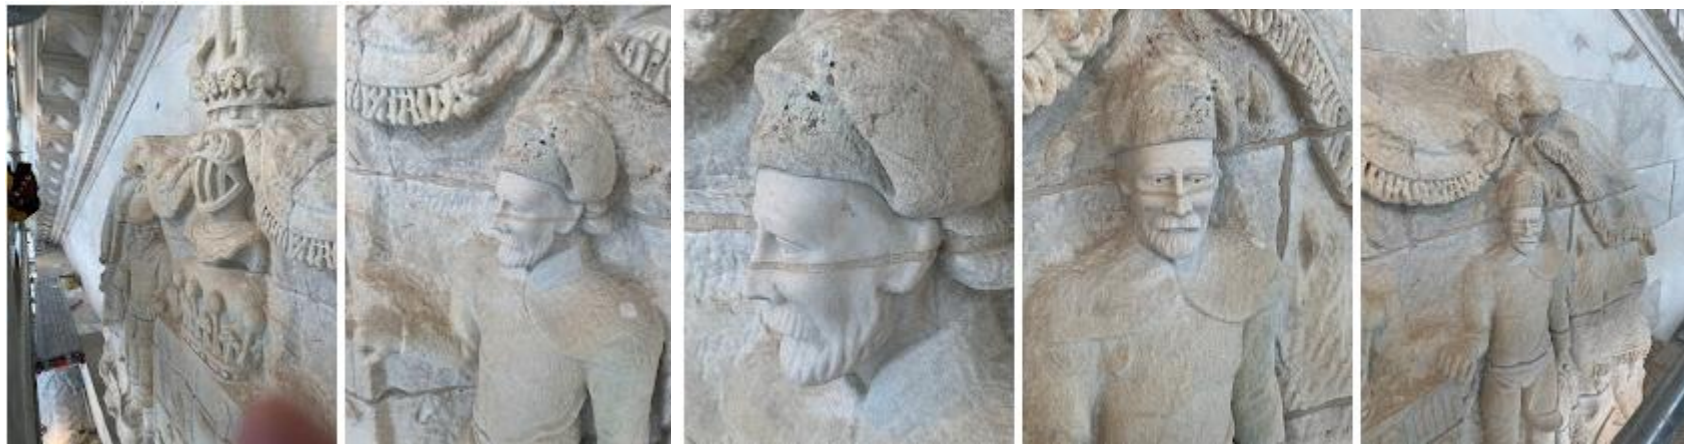
Restoration complete

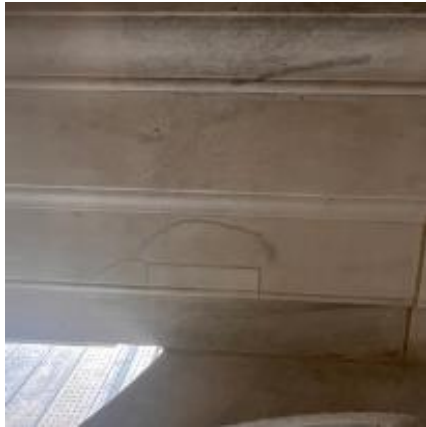
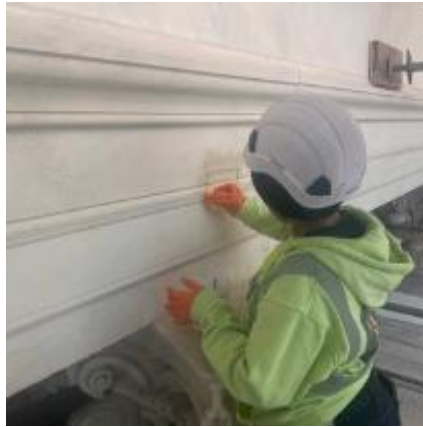
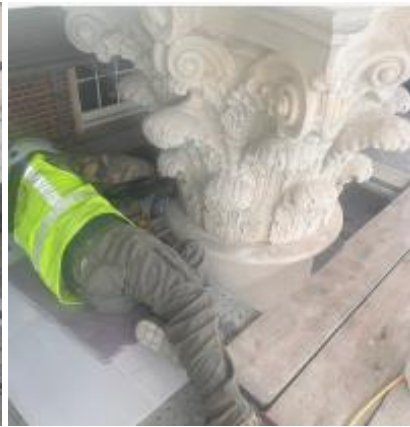
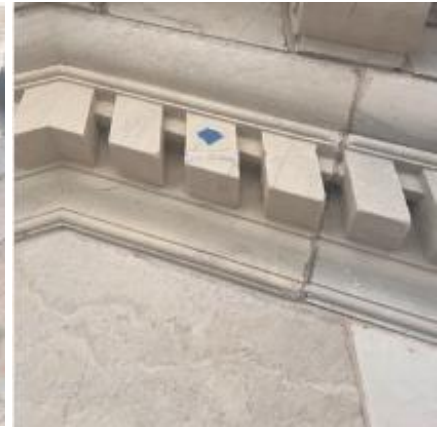
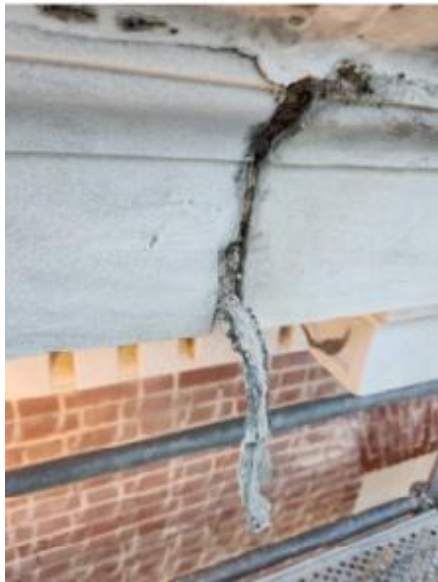
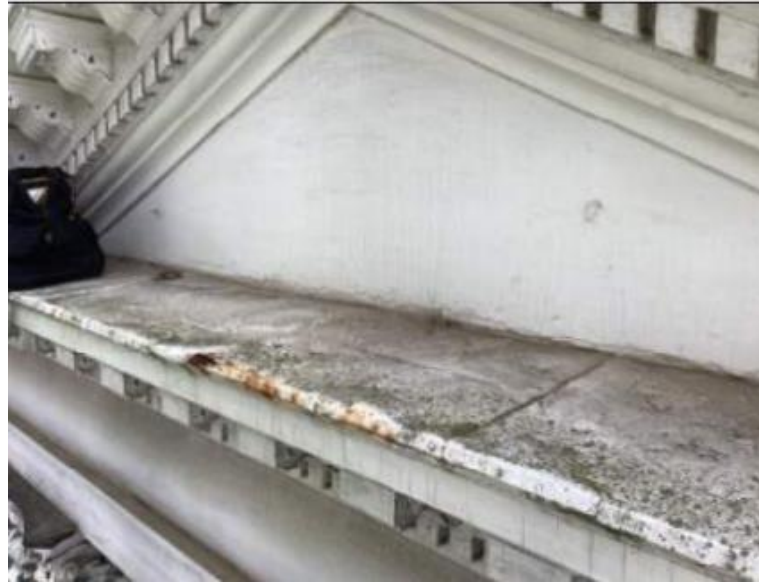
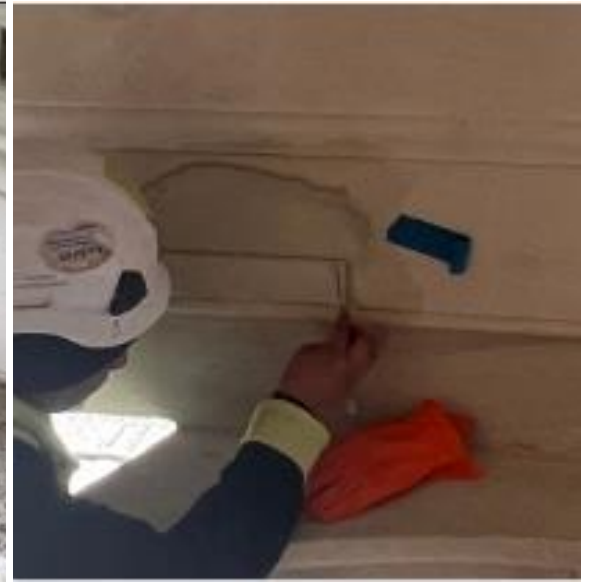
Miscellaneous stone conditions and repairs

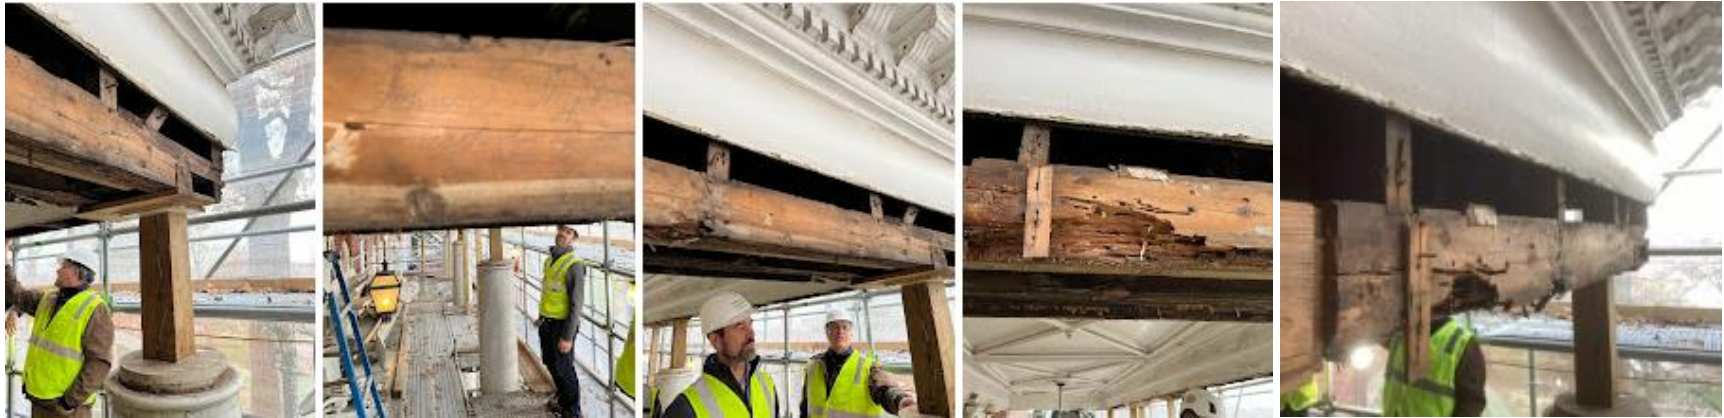
Investigating existing conditions and structural issues

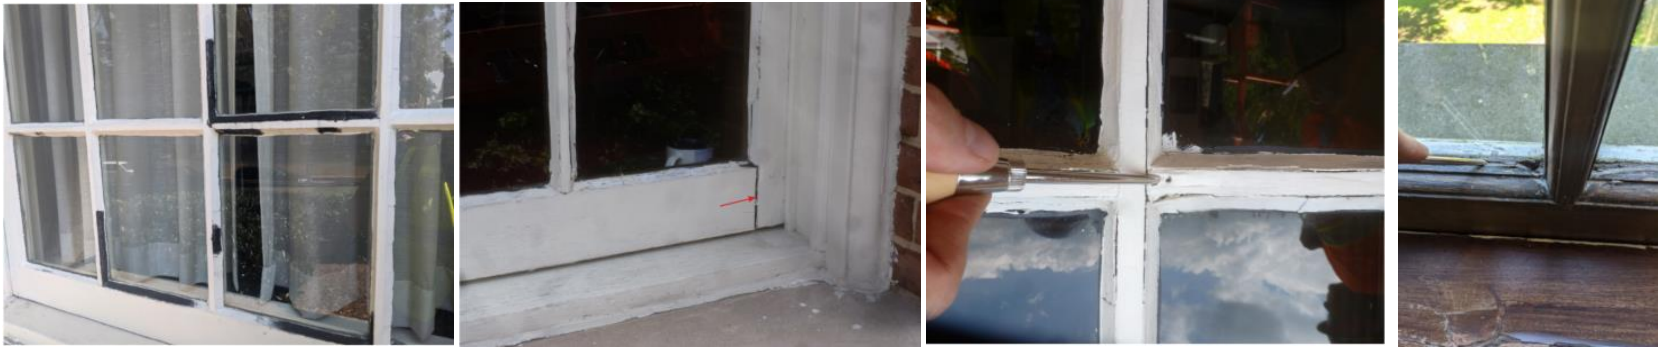
Existing conditions prior to window removal

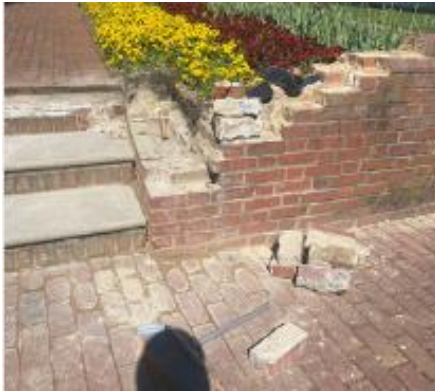
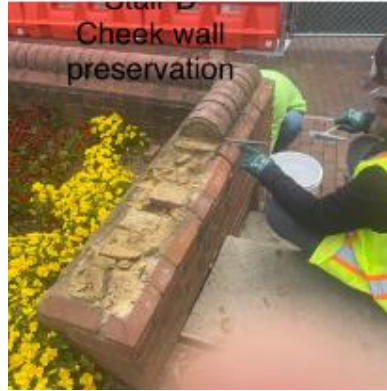
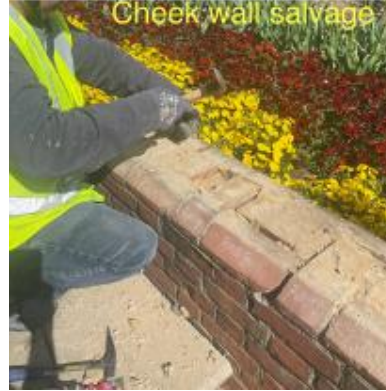
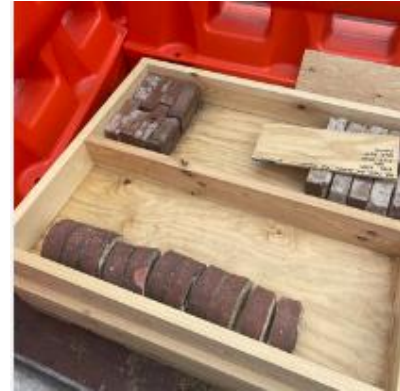
Retaining wall restoration has begun with selective deconstruction, salvage of materials for re-use and establishment of a temporary construction entrance
